**CORNET**  
**Final Report / Schlussbericht**

**IN2EuroBuild**  
**Consistent European Guidelines for Internal Insulation of Building Stock and Heritage**  
**Einheitlicher europäischer Leitfaden für die Innendämmung von Bestandsbauten und Baudenkmalern**

**Holzkirchen / Dresden / Limelette, 14.07.2022**

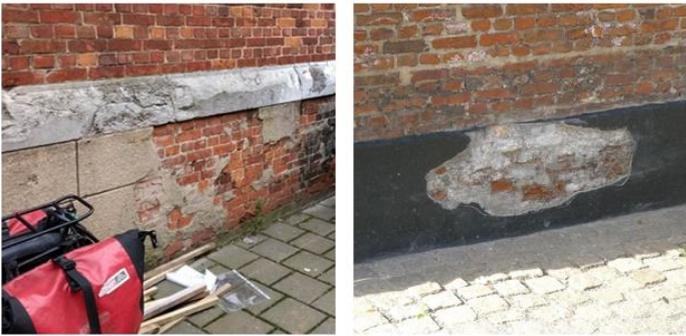
**Case 15 Degradation of protection materials near the wall base**

Powdering, flaking, cracking, detaching of materials. Usually, the degradation might become very intense, because of the high moisture and salt-exposure.

**CAUSE**  
Mostly through the action of frost or salts, combined with an underlying humidity problem, for instance rising damp or splash water (ground inclined towards wall).

- Any underlying humidity problem should be resolved (e.g. rising damp)
- Restore the building materials. It might be necessary to use materials with a lower water uptake and higher frost resistance.
- Rainwater drainage at the wall base (e.g. through a gravel bed) may be necessary.
- Apply drying measures at the inside if necessary.

Figure 1: Example of a damage pattern that is explained in the appendix

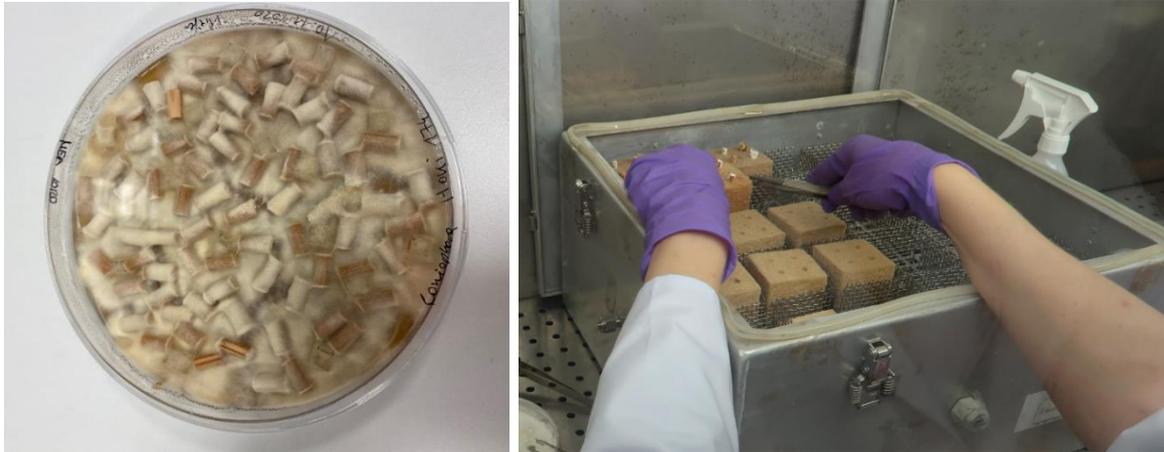
Figure 16: Overgrown wooden dowels with test fungi *Coniophora Puteana* (left) and transfer of the dowels into the test specimen (right).

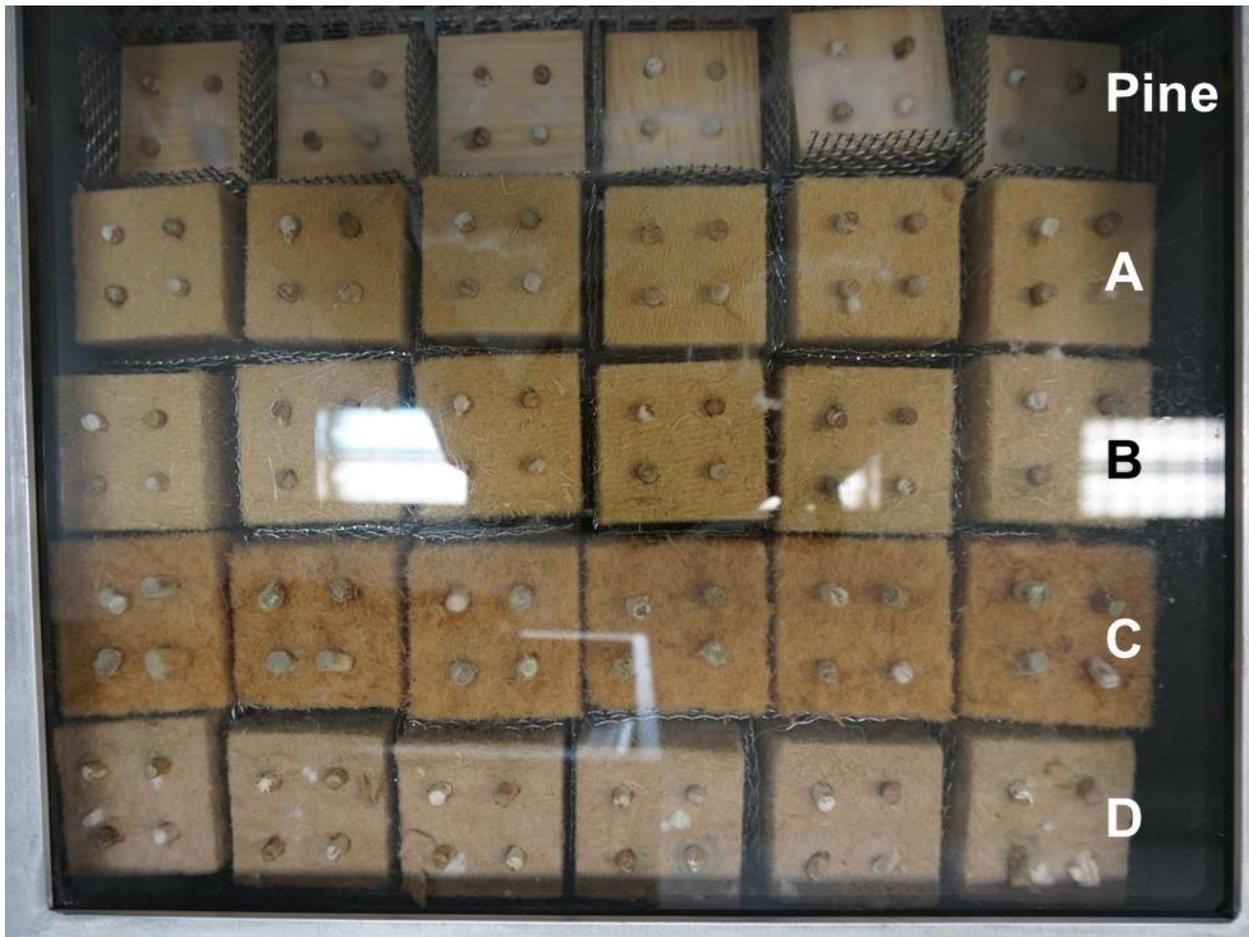
Figure 18: Visual observation after 25 weeks: Some mould growth appeared in two of the 6 incubation units. It was initially observed on the dowels of the flexible fibre insulation C after 12 weeks.

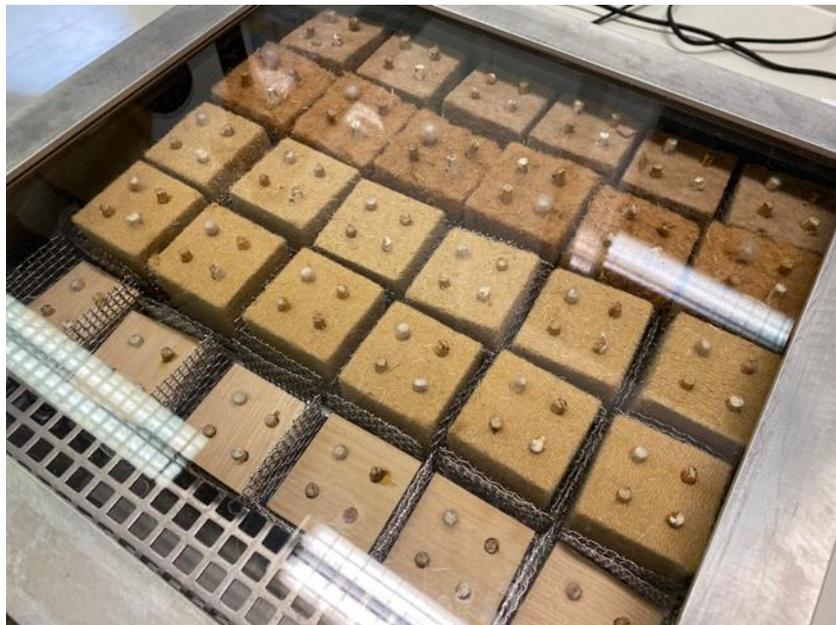
Figure 19: Test specimens with overgrown dowels in an incubation unit. View through the glazed lid.

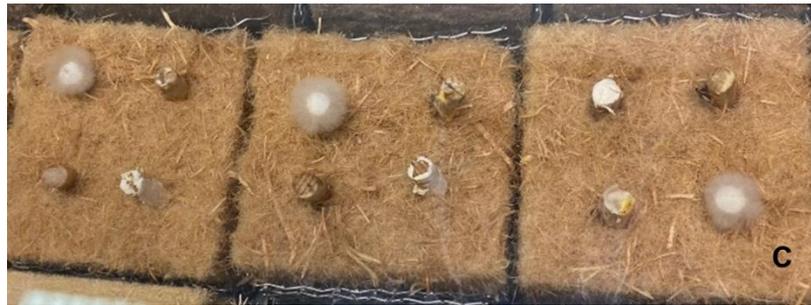
Figure 20: Visual observation after 8 weeks: fungi growth on the dowels in the flexible fibre insulation C. While a strong mycelium growth of *Schizophyllum commune* can be detected on the dowel itself (but no transfer to the specimen) only moderate growth can occur for the three other fungi.

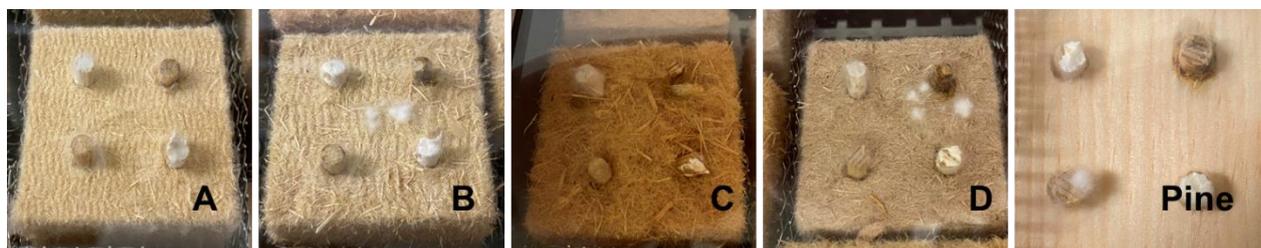
Figure 21: Visual observation after 8 weeks: established mycelium growth on all specimens apart from the flexible fibre mat C

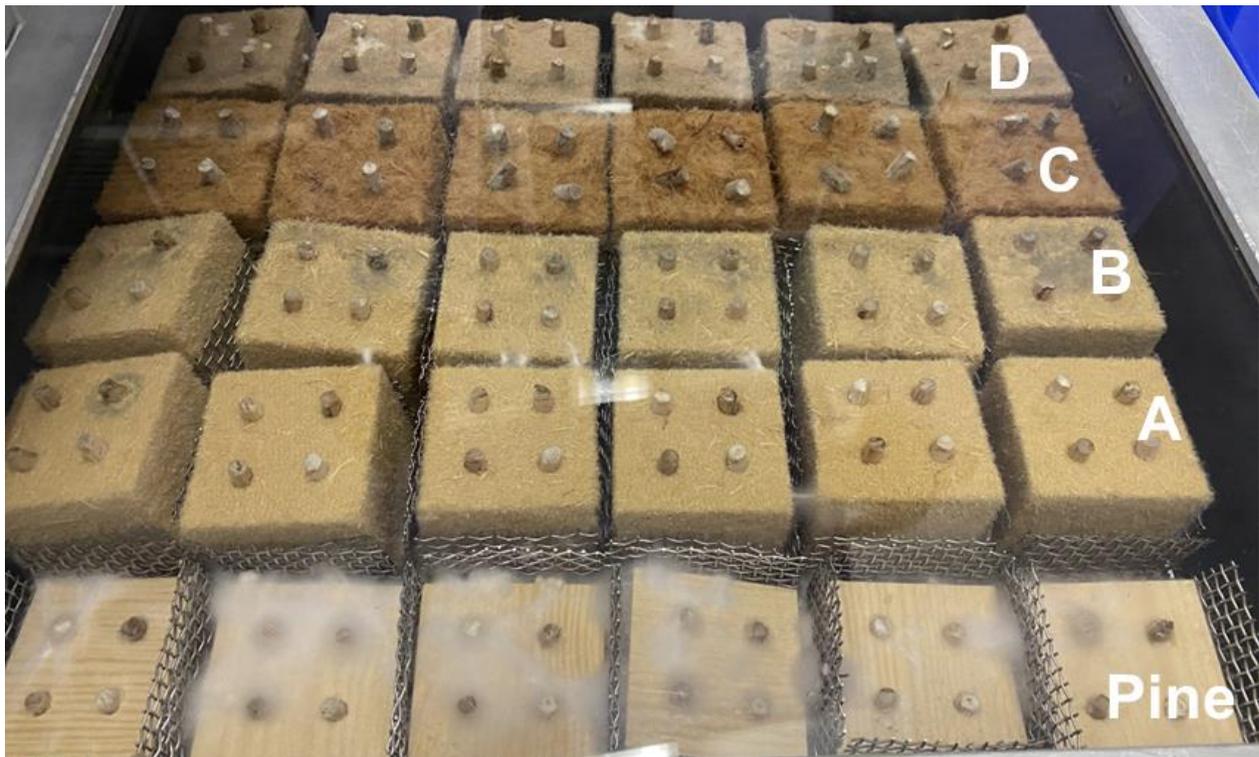
Figure 23: Visual observation after 40 weeks: Clearly strongest mycelium growth on the Pine, mould growth on materials B and D as well as on the dowels of material C. Some visible growth of mould and decay fungi on material A.

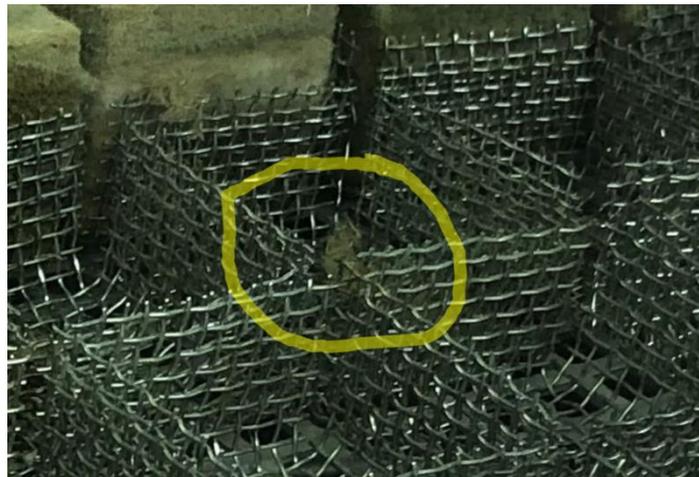
Figure 28: Parts of the flexible fibre mat stuck to the metal basket.

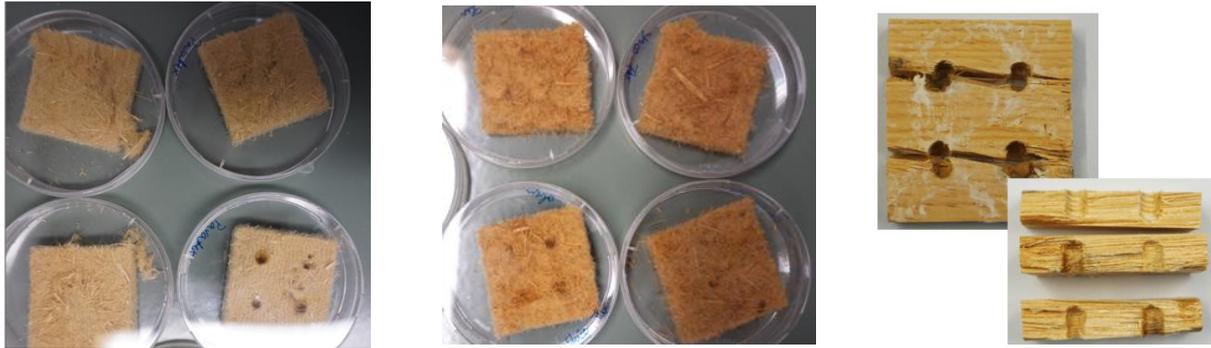
Figure 30: Cut specimens after 40 weeks of incubation. Dry board A (left), flexible mat C (middle) were horizontal sliced and pine sapwood (right) was cut along holes,

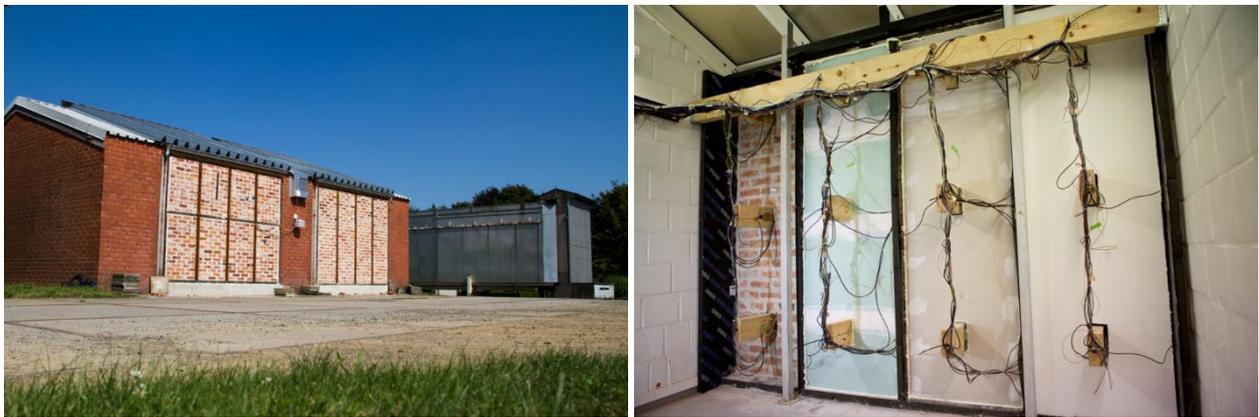
Figure 38: Left: Test house at the BBRI test facility; right: One of the two test chambers at the BBRI test facility from the inside. From left to right: non-insulated wall, EPS, mineral wool and calcium silicate. The three beams per wall represent a different connection between masonry and beam. The top beam parallel to the wall only serves as a structural support for the wall

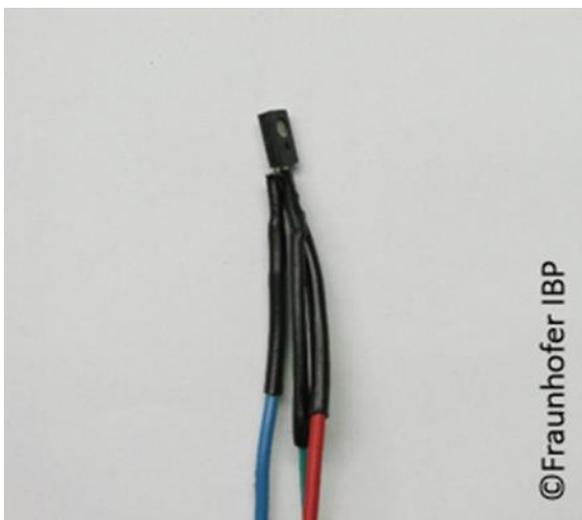
Figure 47: Calibration measurement of the used NTC`s in comparison with the reference sensor

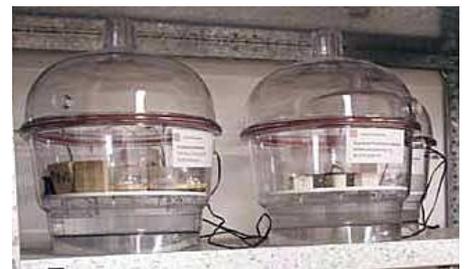
Figure 49: Calibration by means of desiccator with 3 humidity levels

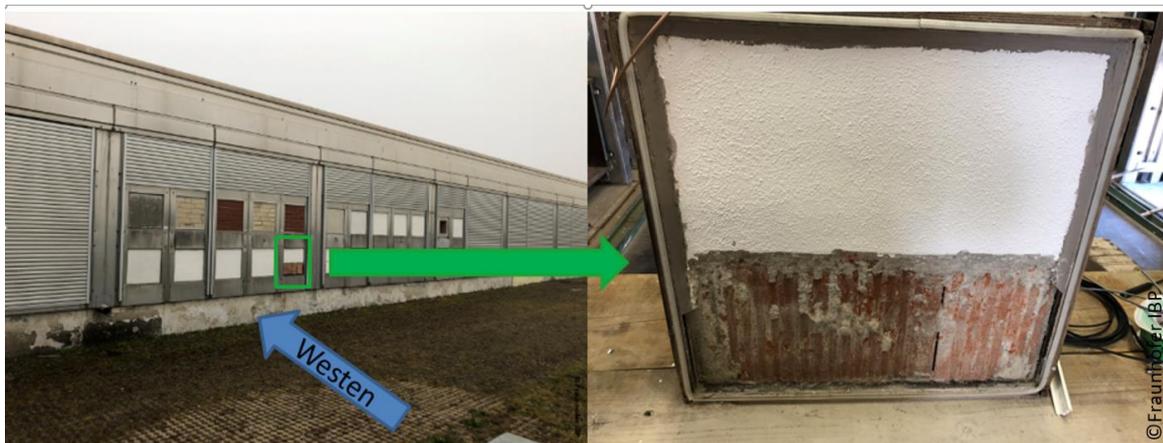
Figure 51: Installation situation of the measurement system in the outdoor test facility at the Holzkirchen site. Left: the test specimen in its installed state. Right: the figure shows the surface design of the test specimen with the exterior plaster removed

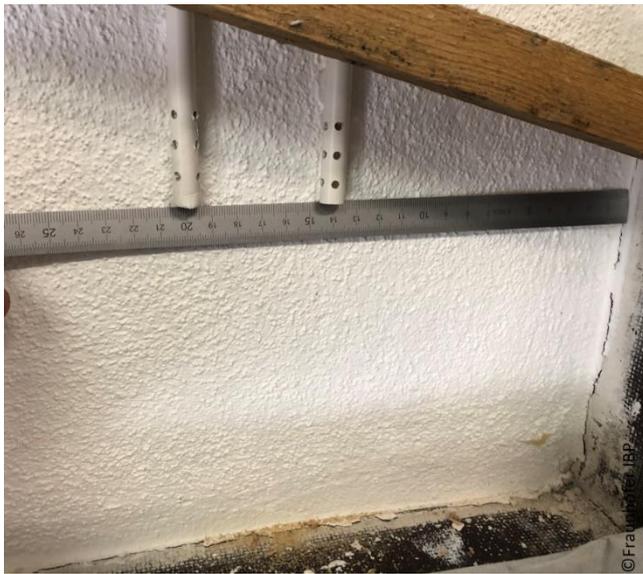
Figure 52: Perforated plastic tubes for the installation of the temperature and rel. humidity sensors within the interior insulation system

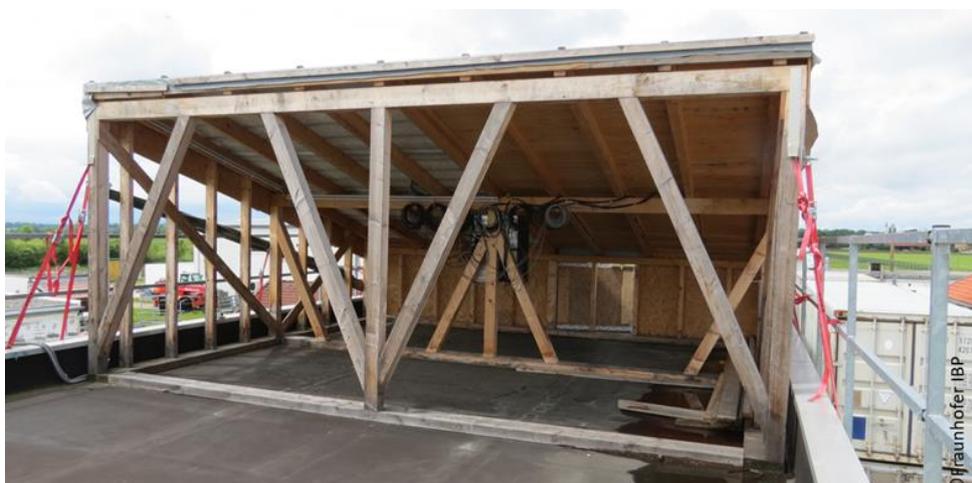
Figure 53: Flat roof test bench within the field test facility at the Fraunhofer IBP in Holzkirchen

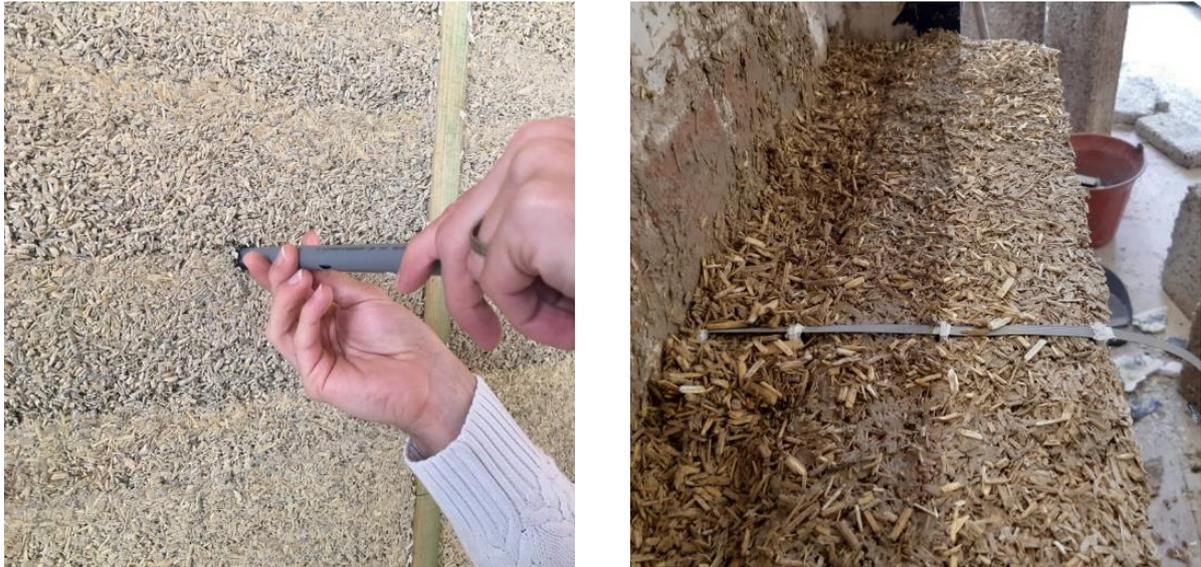
Figure 60: Installation of measuring probe in the wall, either using a PVC tube (left), or during construction (right)

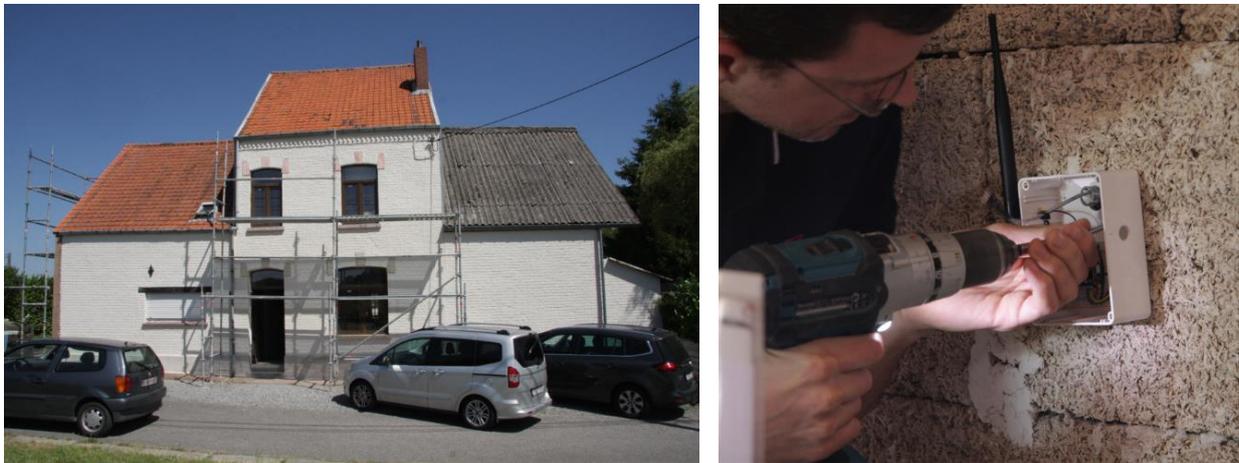
Figure 65: Building in Wavre where the monitoring system was tested

In Wavre, an existing building was renovated in the course of 2018 and 2019 (Figure 65). This building is divided into two zones: a living area and an office. In total, a measurement probe is placed in five different places in this building: three in the living area and two in the office. The measurements started about half a year after the main renovation works. However, some works were only placed during the measurement campaign (such as the interior and exterior plastering in certain places).
