PILOT STUDIES WITH A PHOTOGRAMMETRIC GLACIER LAKE OUTBURST FLOOD EARLY WARNING SYSTEM

Hans-Gerd Maas¹, Christian Mulsow¹, Anja Wendt², Gino Casassa²

KEYWORDS: Photogrammetric network, image sequence processing, disaster monitoring

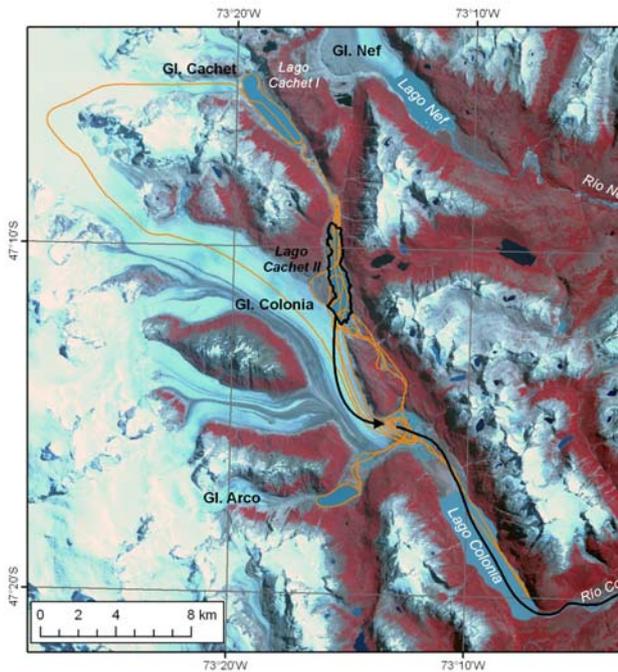
Figure 1: Satellite image of *Lago Cachet II* glacier lake drainage paths (in black) at *Glaciar Colonia* (Casassa et al., 2009)

An example of such a disastrous event is the GLOF at *Lago Cachet II* in the Northern Patagonian Icefield at 6.-7. April 2008 (Casassa et al., 2008). *Lago Cachet II* is dammed by the *Glaciar Colonia* (Figure 1).

The lake has a length of 5 km, a width of 1 km, a maximum depth of 100 m and a volume of ca. 200.000.000 m³. For *Glaciar Colonia*, a surface decrease of 9.1 km² (2.7% of the total surface area) has been reported for 1979-2001 (Rivera et al., 2007); Masiokas et al. (2009) report a glacier front retreat by ca. 1 km; Casassa (2009) reports a thinning of the glacier tongue, which is about 2 m/a in the region of the *Lago Cachet II* contact.

In the evening of 8. April 2008, the lake began to drain through a tunnel of 8 km length, which had developed at the glacier bottom. The waters flooded the *Colonia River* valley and flew further into the *Rio Baker*, the largest river in Chile, where the water level rose by 4.5 m within 48 hours and the discharge increased from 1200 m³/s to 3600 m³/s (report Dirección General de Aguas, 2008). Several similar events were observed in the time since then. Also for the close-by smaller *Lago Nef Norte*, which is dammed by *Glaciar Nef*, several GLOFs were reported since 2008.

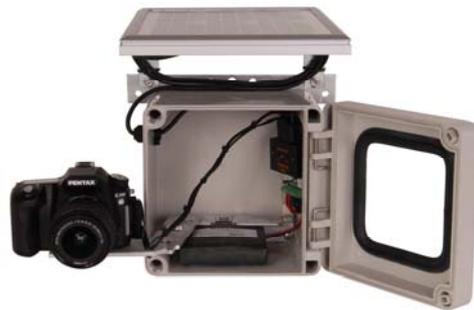
The cameras were *Harbortronics* time lapse cameras (Figure 2), consisting of an 11 Mpix off-the-shelf SLR camera, a timer, a waterproof body, a solar panel and a buffer battery.

Figure 2: *Harbortronics* time lapse camera package

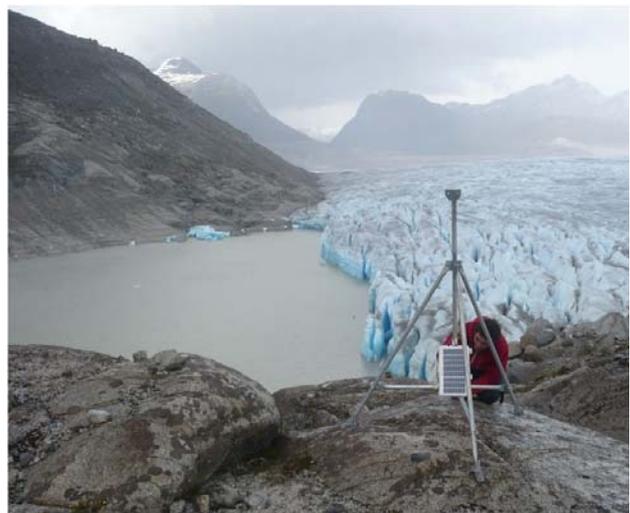
The cameras were installed on stable tripods (Figure 3). Some fiducials were installed in the foreground in order to verify the camera orientation stability and to correct for wind-induced orientation changes.

Figure 3: *Harbortronics* camera installation at *Lago Nef Norte*

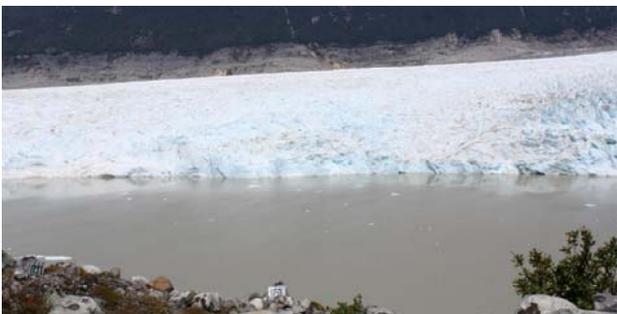
Figure 4 shows a camera image at *Lago Cachet II*.

Figure 4: Camera image at *Lago Cachet II*

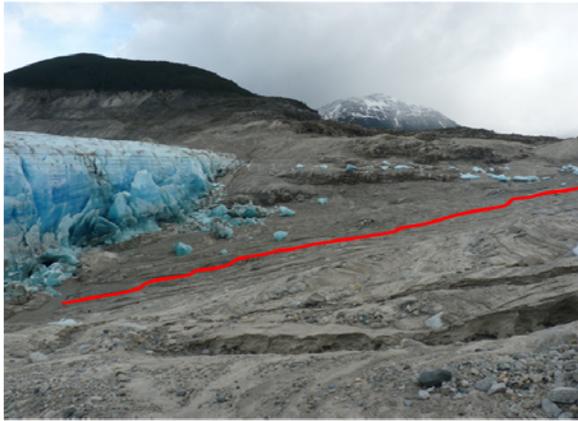
- Photogrammetric height profile generation: Two of the photogrammetric network images for the georeferencing procedure as described above were used for the interactive measurement of a height profile of the visible part of the lake basin (see principle in figure 5).

Figure 5: Lake basin profile for slope determination

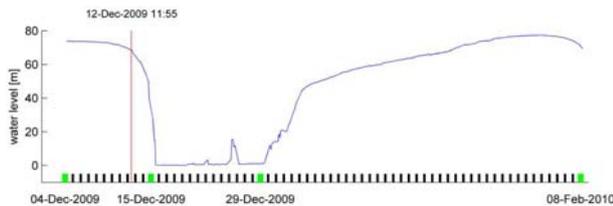
Figure 6: Water level at *Lago Nef Norte* over a two months period

At *Lago Nef Norte*, seven images per day were taken in two hour intervals between 4.12.2009 and 8.2.2010. At *Lago Cachet II*, a sequence from 27.11.2009 to 10.2.2010 with only one image per day was available. The sequence at *Lago Cachet II* shows two GLOF events within two weeks (but both not with a complete drainage of the lake), the sequence at *Lago Nef Norte* shows one (complete) GLOF. In fact, *Lago Nef Norte* drained again at 10.2.2010, just after the end of the sequence.

In the course of the pilot study, one image sequence at *Lago Nef Norte* and one at *Lago Cachet II* were acquired and processed. The results are shown in Figure 6 and Figure 7.

Obviously, the photogrammetric system is only one part of an early warning system. The system has to be completed by a data telemetry system as well as warning and evacuation schemes. A visual camera based system will not be able to take images at night. However, GLOFs occur usually in summer in regions of larger latitudes, so that one must mostly only anticipate short interruptions of the image sequences of a few hours; this can be tolerated due to the progressive development of typical GLOFs, which can also be seen in Figure 6 and Figure 7.

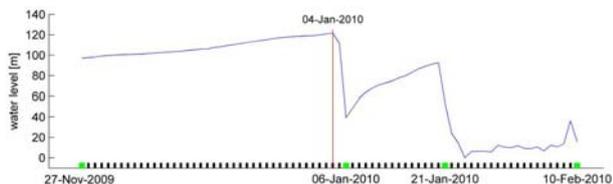
Figure 7: Water level at *Lago Cachet II* over a two months period
