Risk Management of Extreme Flash Floods

Pathways: Hydrological Aspects and Engineering Measures - an Event Perspective of the Müglitz Flood 2002 -

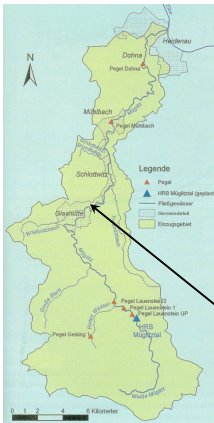
The Müglitz River Basin

Length: 48.9 km

Catchment area: 210 km²

altitude difference: 750 m

Valley shape: V-type, narrow, smaller creeks joining the course

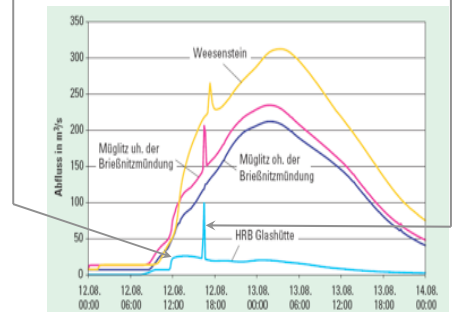
The tremendous discharge of Briebnitzbach caused by the heavy rainfall was locally stored in Glashütte flood control reservoir until the outlet was blocked by sediments.

The following overtopping of the dam caused an immediate erosion of the dam surface followed by the crash of the dam. The tremendous flood wave of ca. 50.000 m³ dashed down the valley and the function of the flood control reservoir failed.

12 August, 16.30: the dam of the Glashütte flood control reservoir broke. An amount of 50.000 m³ flushed downwards to the valley.

A flood wave of 4 m height outpoured into the town of Glashütte and destroyed houses and infrastructure.

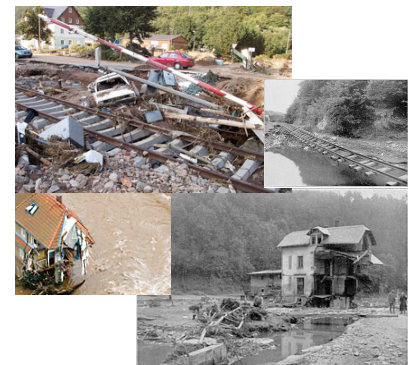
This event was denoted as a less than once-in-one-hundred-years event. Similar damages are shown in pictures from 1927 when still no flood control reservoir existed.
