Sources And Pathways of Extreme Coastal Floods

- A "Pre/Post-Event" Perspective of the Storm Surge of 1962, German Bight Coast -

International Teaching Module
FLOODmaster
 Integrated Flood Risk Management
 of Extreme Events

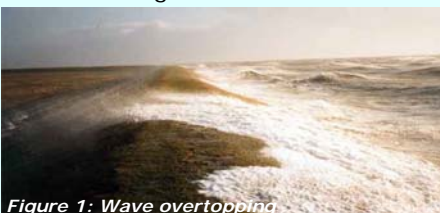
•Wave overtopping: high waves running up at the seaward side waves are higher than the dike

Figure 1: Wave overtopping

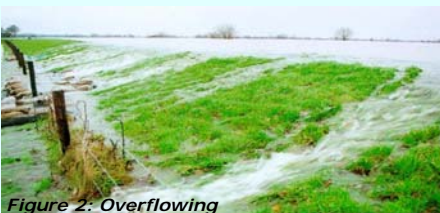
•Overflowing: waterlevel at the seaward side higher than the dike, water flows over the dike

Figure 2: Overflowing

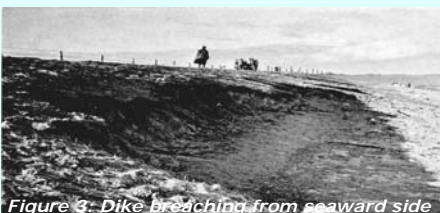
•Breaching – from seaward side: due to wave impact the seaward slope is eroded, creating holes and cliffs that lead to breaching

Figure 3: Dike breaching from seaward side

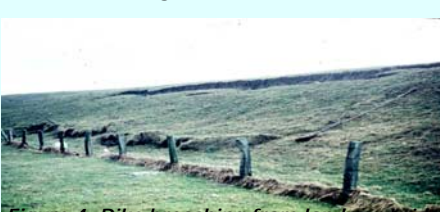
•Breaching – from landward side: due to overflowing and infiltrating water the landward slope is eroded, followed by sliding of the clay cover and breaching

Figure 4: Dike breaching from landward side

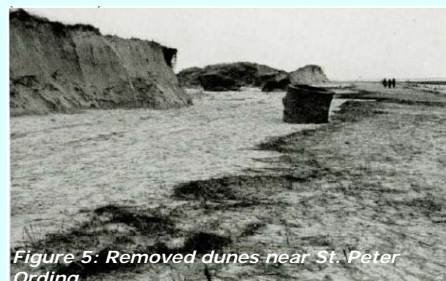
Figure 5: Removed dunes near St. Peter Ording

During the flood event in 1962 the sea dikes between Brunsbüttel-koog and Husum were affected in an extremely hard way. Besides many other places, where people had to be evacuated, the dikes of the Köge in the north of the peninsula Eiderstedt were damaged extremely severely. The dunes in front of St. Peter Ording were partly removed.

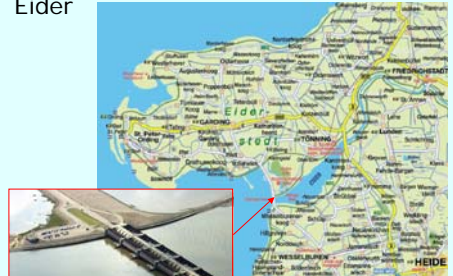
Figure 6: Eider Barrage

The storm flood in 1962 lent urgency to a dam at the Eider river. From 1967 to 1973 the Eider barrage was erected. The Eider dam is close to the mouth of the river between Hundeknöll and Vollerwiek. Each of the five 40-m-wide openings has two radial floodgates. One for protecting the hinterland from tidal waves and one to hold back water on the river. The Eider barrier, used as a secondary coastal defence line, is a reduction of the length of the dike from 60 km to 4.8 km.

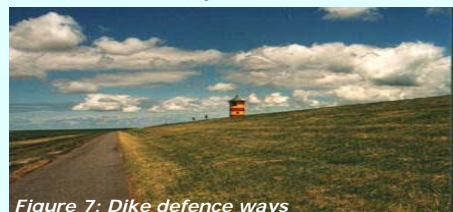
•Coastal Protection: Construction of dike defence ways

Figure 7: Dike defence ways
